OBD/SS ARC-R Adaptive Ride Control Bypass Module (Z45 - 2022.5 and up Refresh GM 1500 Trucks)

The 2022 Model year is a half year. This bypass is for the NEWER trucks.

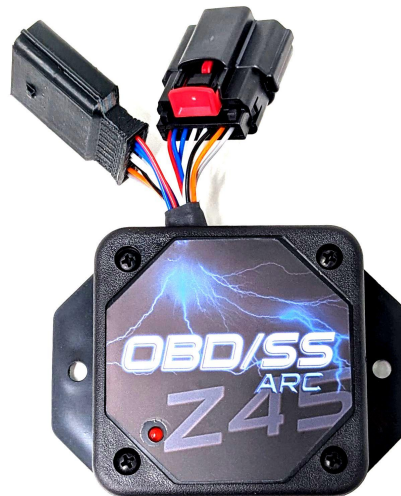
The **OBD/SS ARC-R** is a CANbus transceiver that manages the various tasks required to keep the other vehicles systems operating normally with the removal of the Z45 suspension. The module will 'wake up' and 'sleep' as the truck turns on and off. The truck will think there is a fully functional Z45 suspension system operating normally. The following can be removed from the vehicle if desired, shocks, struts, ride height sensors, and Suspension Control Module (SCM).

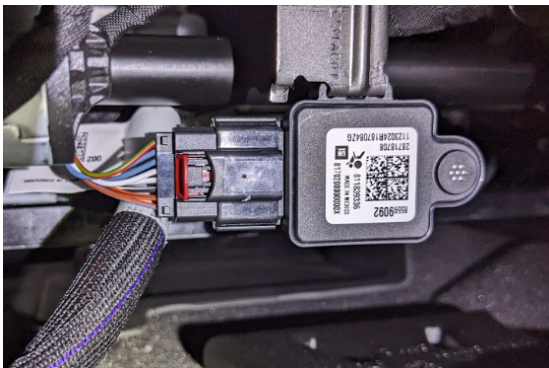
Step 3: Plug the OBD/SS ARC-R into the 8 Pin - module located under the front passenger side seat in plain view.

Unplug the 8 pin female from the module under the seat.

Plug in our female plug to the module.

Plug our male plug in the originally unplugged 8 pin female connector.
